INFO-TECH CITROËN Racing C2 R2 and C2 R2 MAX N° 29/10.

Subject: Engine power cut.

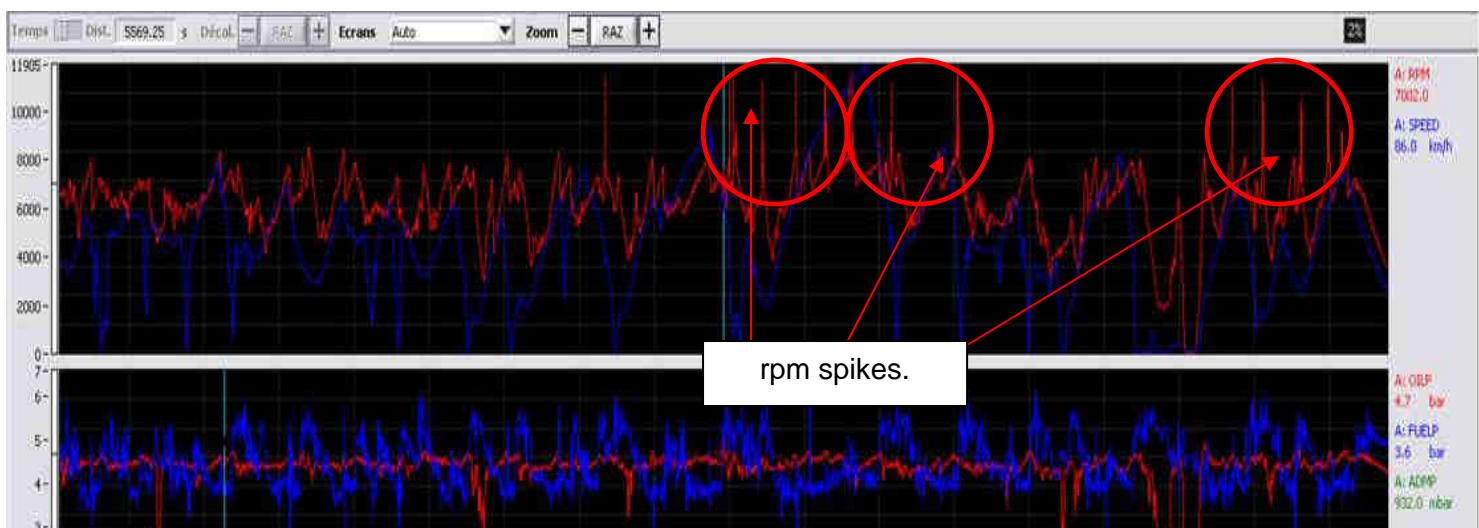
If you encounter some engine power cut on your C2R2 MAX it might be due to a default of the engine speed sensor.

If you have the data acquisition, you can visualise the default as shown on the picture below :

In order to limit the risk of appearance of this default it is wished to modify the engine speed sensor to increase the air gap and get a stronger signal.

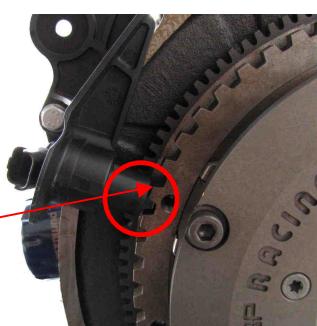
Modification of the distance between the engine speed sensor and the flywheel.
Original value 0.8mm
