INFO-TECH CITROËN Racing C2 R2 MAX N° 17A/09.

Subject : Engine loom, motorised throttle connector .

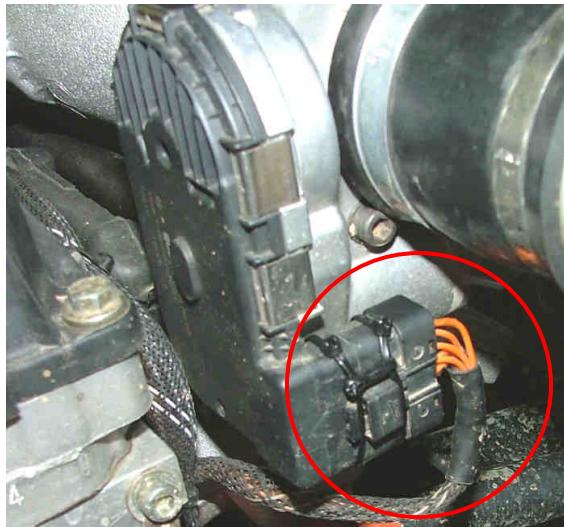
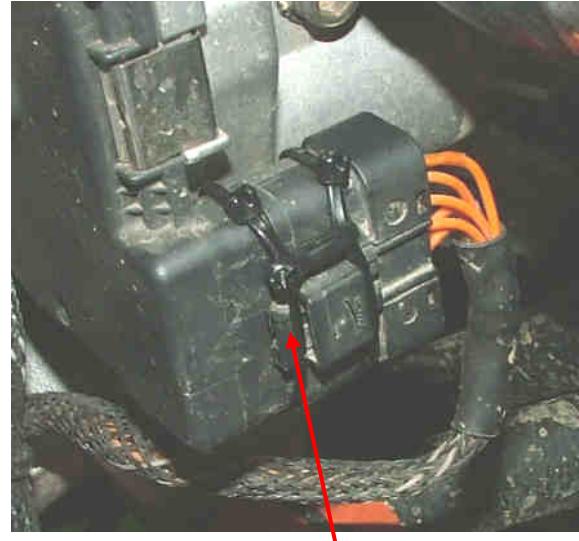
The tie rap on throttle body side (shown on pictures below) was tightened below the locking pin of the throttle connector. This way, a disconnection of the connector was potentially possible.

Tie rap assembly over the locking pin

So, we suggest you to assembly the tie rap over the connector locking pin, as shown on pictures below :
