E44 : RACK (For GT)

RACK ASSEMBLY

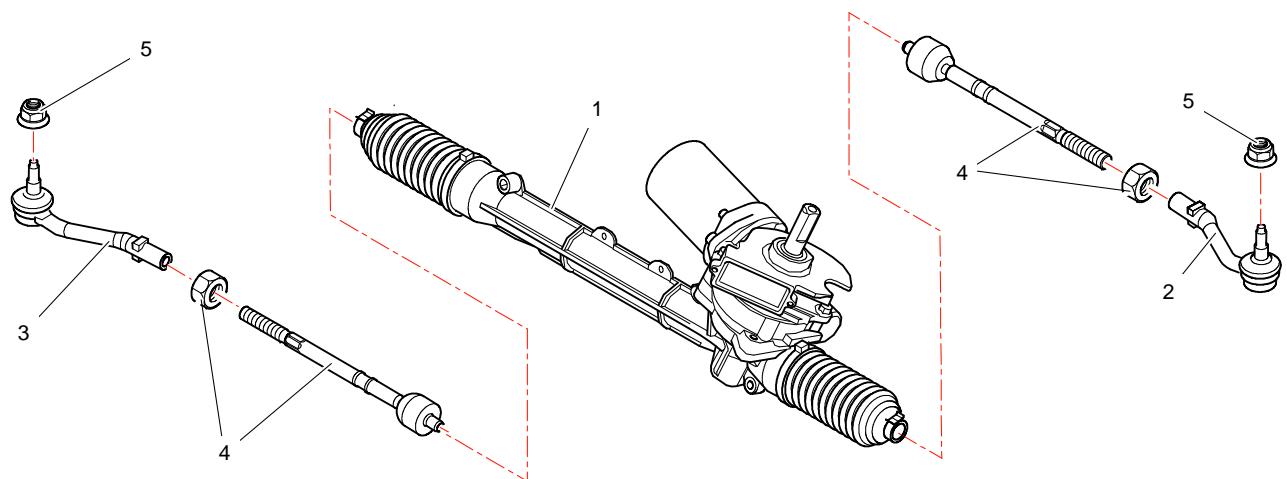
C2-C014A

Steering link / rack torque	5 m.kg + Loctite 242

Steering ball joint / front up-right torque	3.5 m.kg
!!!	<p>On tarmac but more often on gravel, a steering arm can be bent after a wheel shock with a big stone or something else. On the service, you absolutely need to change it, otherwise it will break the shock after.</p> <p>When a steering arm is broken, the wheel angle is too big, and the driveshaft is not able to support it. You need to check the driveshaft, or the best is to change it.</p>
