INFO-TECH CITROËN Racing C2 R2 MAX N° 23/09.

Subject: Gearbox bracket.

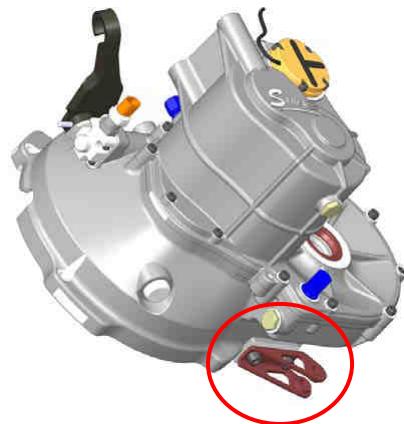
We ask you to pay attention about the loosing of the gearbox anti torque bracket.

The loosing of this bracket may create a dangerous engine movement (around engine and gearbox mountings) and damage the gearbox body and the bracket.

We recommend you to check the bracket tightening in accordance with gearbox SADEV notice sheet (loctite 243, torque 5.5 DaN.m).
